Commercial Valve Troubleshooting Webinar

Harland Hirtzel, Product Manager

September 15, 2010

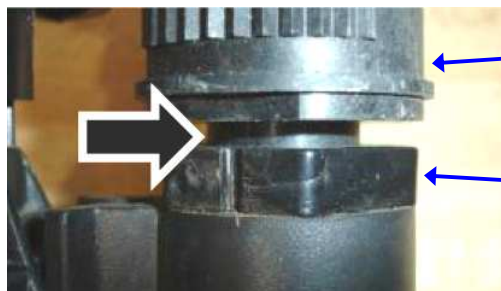
Example:
Gap Is Too Wide

No Close - Weeping Or Full Open Loose Solenoid

Solenoid

Adapter

PROBLEM: The solenoid is not fully tightened. The pilot dump line will be constantly open which in turn keeps the valve open.

SOLUTION: Tighten the solenoid using the handle/wrench to "hand tight".

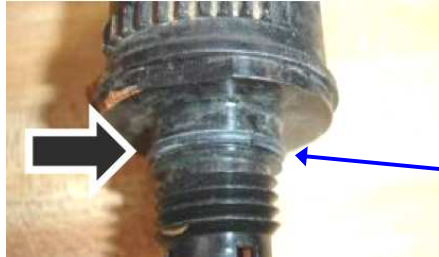
Example:
O-ring is Nicked

No Close - Weeping Or Full Open Solenoid O-Ring Damage

Solenoid O-Ring

PROBLEM: The solenoid o-ring is damaged. Pilot is vented to atmosphere which allows the valve to stay open constantly or intermittently.

SOLUTION: Replace the o-ring or replace solenoid assembly.

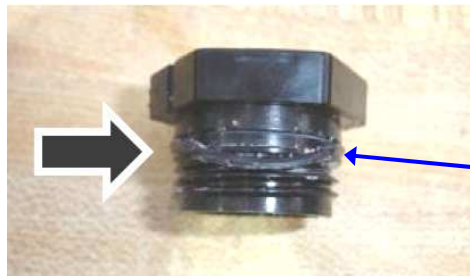
Example:
O-ring is Not
In Groove

No Close - Weeping Or Full Open Adapter O-Ring Damage

O-Ring

PROBLEM: The adapter o-ring is either damaged or installed improperly. The valve pilot is vented to atmosphere which allows the valve to stay open constantly or intermittently.

SOLUTION: Replace the o-ring or replace the adapter assembly.

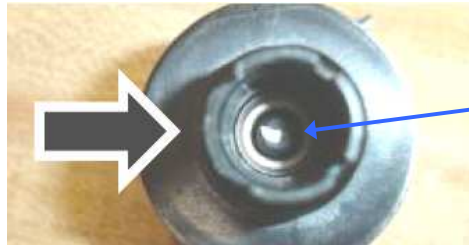
Example:
Debris Has
Lodged In
Seal Face

No Close - Weeping Or Full Open Debris on Plunger Seal

Plunger
Seal Face

PROBLEM: Debris has been deposited on the plunger seal face. The plunger cannot seal off the pilot dump hole which keeps the valve open.

SOLUTION: Remove the plunger, rinse with water and reinstall. If seal has been damaged, replace the plunger or replace solenoid assembly.

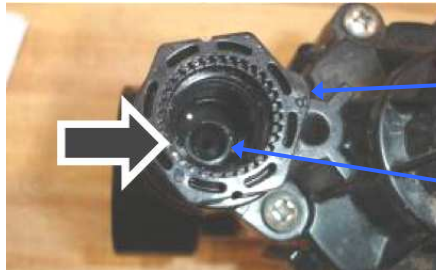
Example:
Solenoid Seal
Is Missing

No Close - Full Open Missing Parts

Solenoid
Adapter

White Solenoid
Seal Should Be
Here

PROBLEM: Solenoid seal has been removed. The pilot dump hole cannot be closed and the valve runs full open continuously.

SOLUTION: Replace the solenoid seal.

Note: Also check for plunger, plunger retainer and spring.

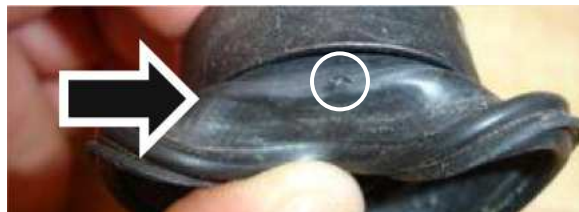
Example:
Debris Has
Cut Hole In
Diaphragm

No Close - Weeping Or Full Open Hole Or Crack in Diaphragm

PROBLEM: A hole in the diaphragm. On forward flow valves, this hole allows the pressure to equalize on both sides of the diaphragm and keeps the valve open.

SOLUTION: Replace the diaphragm assembly.

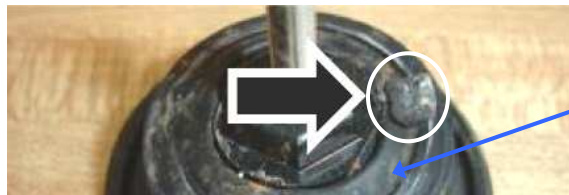
Example:
Rock Has
Been Wedged
In Valve Seal

No Close - Weeping Or Full Open Debris on Plunger Seal

Valve Seal
Face

PROBLEM: Debris has been deposited on the valve seal. This blocks the valve from closing.

SOLUTION: Remove debris. If the valve seal (or seat) is damaged or distorted such, replace the entire diaphragm assembly.

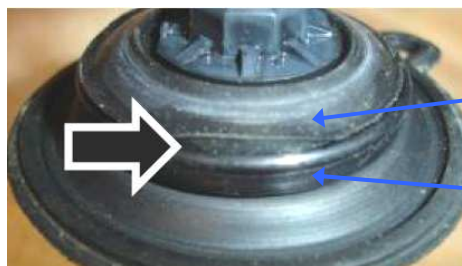
Example:
PEB Valve
Seal Has
Pulled Away
From Support

No Close - Weeping Valve Seal Pop-Out

Seal

Seal Support

PROBLEM: The main valve seal is pulled away from its co-molded plastic support at high pressure and temperature. With the seal cocked to one side, the valve may weep intermittently. Difficult to diagnose because it can correct itself.

SOLUTION: Replace the diaphragm assembly.

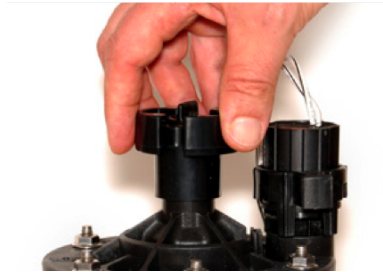
No Open - Low Or No Flow Flow Control Misadjusted

PROBLEM: The flow control has been manually closed or turned down so low that the valve “dithers”, i.e., cycles open and close quickly.

SOLUTION: Fully open the valve and then adjust flow downward until you reach the desired throw on your heads. Then back off ½ turn on the flow control.

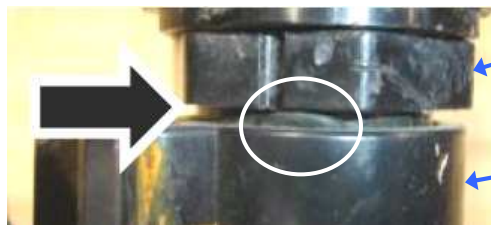
Example:
O-Ring Has
Been Extruded
Out Of Bonnet

Valve Leaks at Adapter Pinched O-Ring

Adapter

Bonnet

PROBLEM: The o-ring can be damaged if the adapter is not fully tightened into the valve bonnet. Then the o-ring cannot provide a good seal.

SOLUTION: Replace the o-ring or replace the entire adapter assembly.

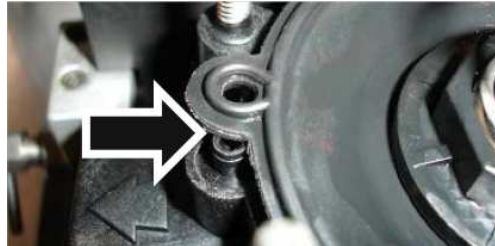
Valve Leaks At Body-To-Bonnet Misaligned Diaphragm Tab

PROBLEM: The diaphragm tab is not lined up with the pilot exhaust port which prevents the diaphragm from sealing in that area. This results in a significant external leak.

SOLUTION: Install new diaphragm. Make sure the hole in the tab fits over the exhaust port.

Note: Applies only to PEB/PESB Valves.

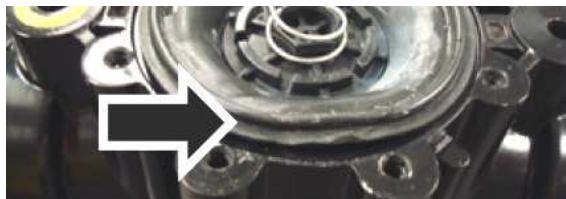
Valve Leaks At Body-To-Bonnet Misaligned Diaphragm

PROBLEM: The outer diaphragm bead has been crushed as a result of not being installed in the groove in the body. This results in a significant external leak.

SOLUTION: Install a new diaphragm taking care to make sure the diaphragm bead fits the body groove all the way around the circumference.

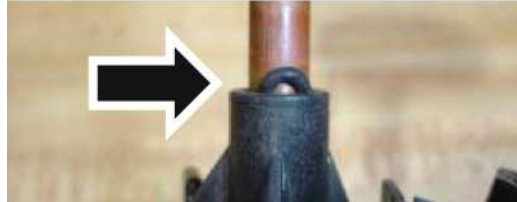
Valve Leaks At Stem Extruded O-Ring Seal

PROBLEM: The o-ring that seals the flow control stem extrudes out of the bonnet under pressure if misapplied. Water then leaks externally around the stem.

SOLUTION: Replace o-ring being careful to lubricate it first.

Note: Can also cause no-close symptoms.

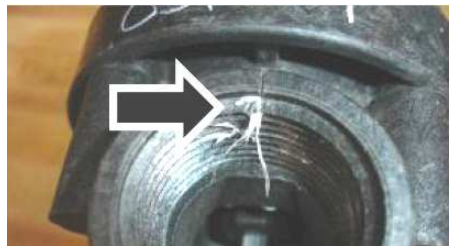
Valve Leaks At Inlet Connection Cracked Body

PROBLEM: A stress fatigue crack starts at the highest stress concentration point inside the valve and propagates out through the threaded connection.

SOLUTION: Replace the valve.
